ALUMINCO S.A. TEST REPORT

STRUCTURAL PEFORMANCE TESTING ON THE *ELXIS RAIL - TYPE B* ALUMINUM AND GLASS GUARDRAIL SYSTEM

13376.02-119-19-R0

08/28/18

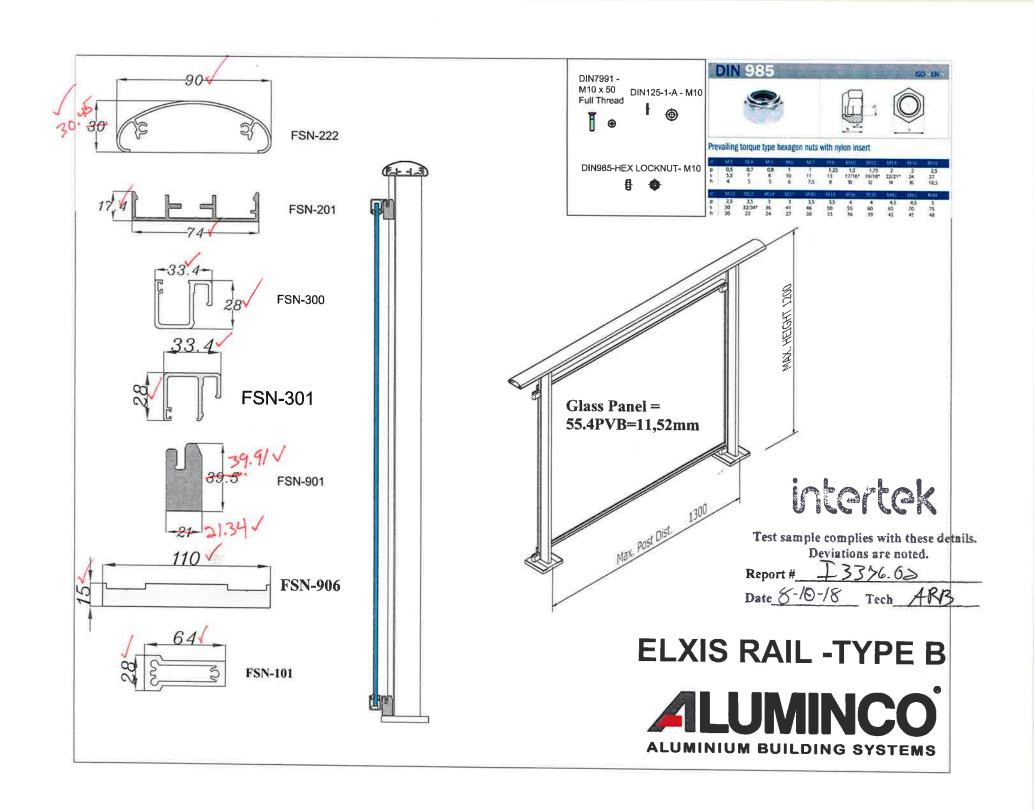
ELXIS RAIL TYPE B LUMINCO ALUMINIUM BUILDING SYSTEMS

-1400--1300-1400-1200 1400 x 1029 (Y) -> MAX. 55.4PVB=11.52mm RODEX 1294 1300-

Test sample complies with these details.

The "As-Built" drawings for the *Elxis Rail - Type B* which follow have been reviewed by Intertek B&C and are representative of the project reported herein. Project construction was verified by Intertek B&C per the drawings included in this report. Any deviations are documented herein or on the drawings.
