**E6337.01-113-11-R0**  
**ACOUSTICAL PERFORMANCE TEST REPORT**  
**ASTM E90**

**PROFESSIONAL GRADE ALUMINUM, INC.**

**Series/Model: W62 Narrow Frame/Narrow Sash**

**Type: Casement Window**

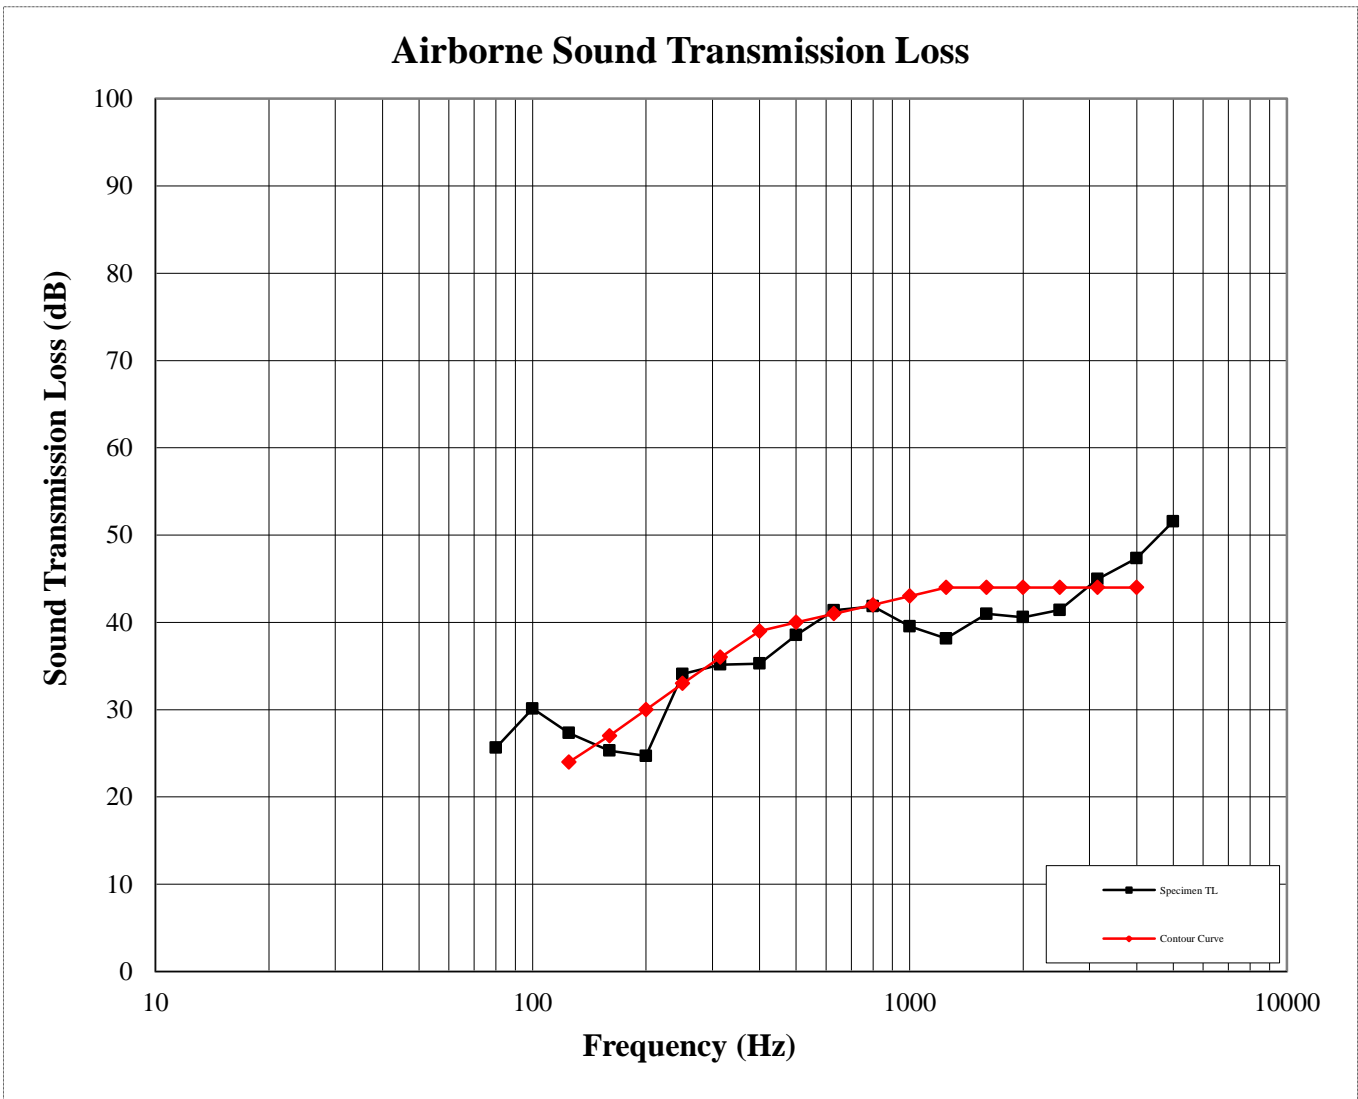
**AIRBORNE SOUND TRANSMISSION LOSS**  
ASTM E 90

<b>Test Date</b>	03/19/15					
<b>Data File No.</b>	E6337.01					
<b>Client</b>	Professional Grade Aluminum, Inc.					
<b>Description</b>	Series/Model: W62, narrow frame/narrow sash casement window with 1-3/8" IG (1/4" annealed exterior, 5/8" air space, 1/2" laminated interior), Glass temperature 75°F					
<b>Specimen Area</b>	1.80 m <sup>2</sup>	Receive Temp.	23.3 °C		Source Temp.	22.1 °C
<b>Technician</b>	Daniel P. Platts	Receive Humidity	49%		Source Humidity	48%

**STC Rating**      **40**      *(Sound Transmission Class)*  
**Deficiencies**      31      *(Sum of Deficiencies)*  
**OITC Rating**      **34**      *(Outdoor-Indoor Transmission Class)*

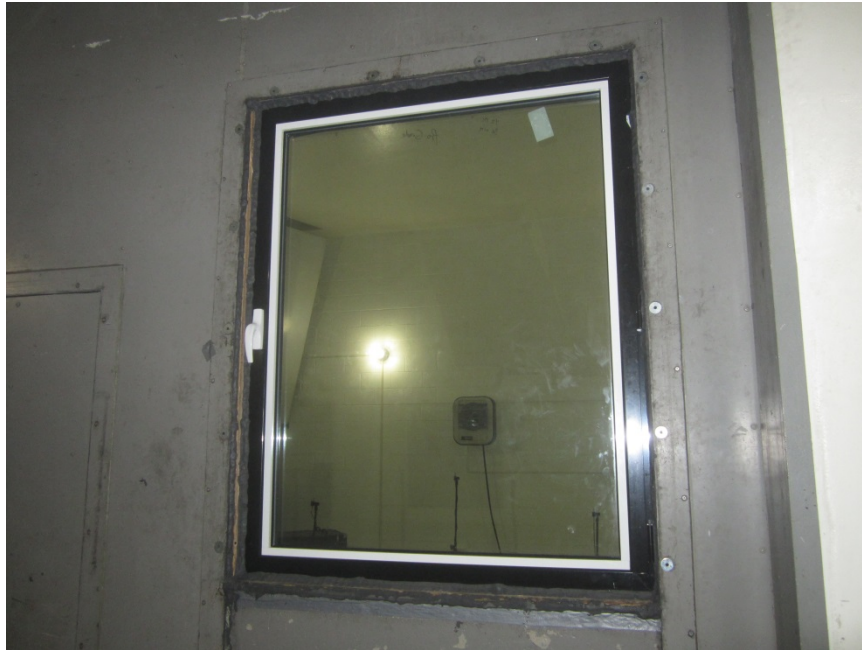
**Receive Room View of Installed Test Specimen**

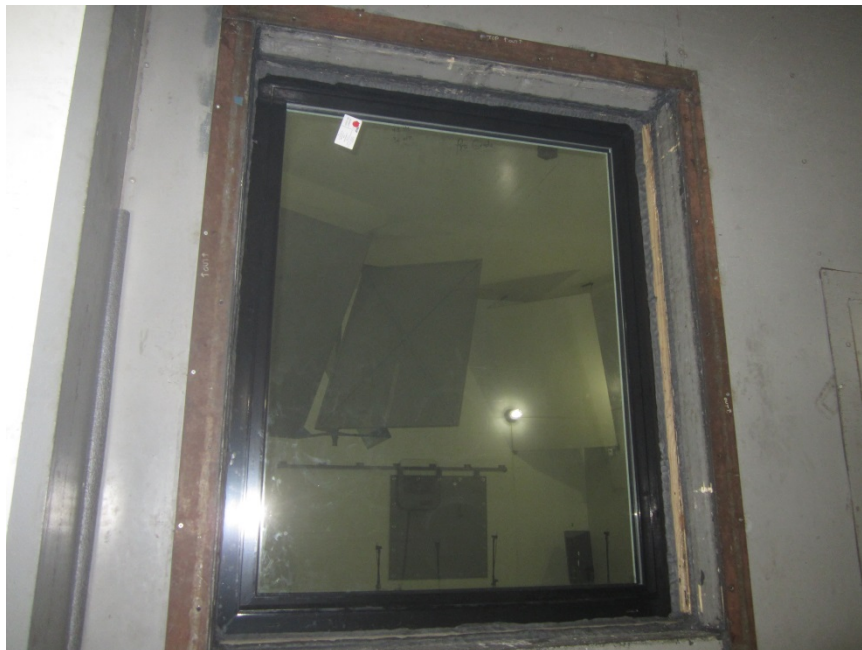
**Source Room View of Installed Test Specimen**
